Condensate pipe leak closes Campus Drive

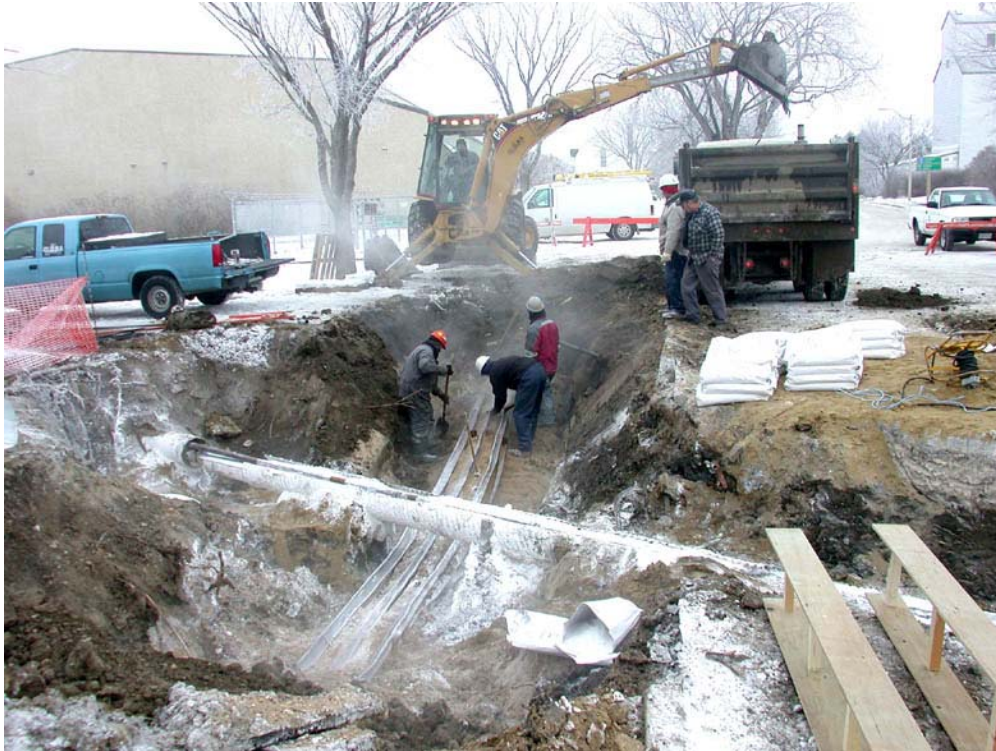
Workers clear dirt away from collapsed electrical conduits running alongside Campus Drive near Rutherford Rink (background) Jan. 14 after having excavated and repaired a ruptured condensate pipe near the Animal Sciences building.

Facilities Management Electrician David Hyde said crews also discovered that heat from the leak damaged electrical conduits running alongside Campus Drive, which are part of the University’s high-voltage distribution loop.

The entire exposed section of two-inch steel condensate line was replaced before the excavation was refilled and the road reopened. Resurfacing will be done in the spring.

Though the condensate line is fixed and the road has reopened, excavation of the nearby electrical conduits will continue for some time, to assess the damage and do repairs.

Power has been re-routed and the repairs won’t disrupt power supply to any areas. Hyde said amply of the melted conduit will be used to support an insurance claim by the University.
